# Reducing Seismic Risk of School Buildings in Venezuela

Oscar A. López,<sup>a)</sup> M.EERI, Julio J. Hernández,<sup>a),b)</sup> M.EERI, Gianina Del Re,<sup>a)</sup> José Puig,<sup>a)</sup> and Luis Espinosa<sup>a)</sup>

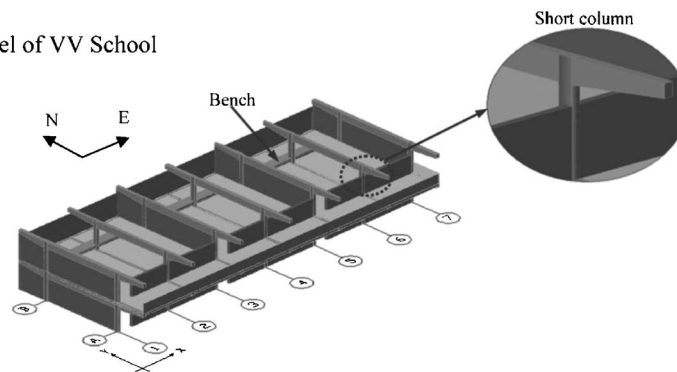
**Figure 1.** (a) Pseudo-acceleration spectrum for the ground motion estimated in Cariaco; (b) idealized model of VV School, Building I, with the roof removed, showing masonry walls, short columns, and concrete bench.

Old-type schools. The height of each story was 3 m. Each building had reinforced concrete frames. Most columns had a 20-cm  $\times$  30-cm cross-section, with the smaller dimension along the longitudinal direction of the building. Frames with beams (20 cm wide by 65 cm deep) were located along the transverse direction of the building, with no beams along the longitudinal direction (Figure 1b). The concrete joist floor system was 25 cm thick and had a 5-cm slab with ribs along the longitudinal direction spaced 50 cm apart. A mean concrete strength of 14 MPa was obtained from testing. Yield stresses were 235 and 276 MPa for the longitudinal and transverse reinforcement bars, respectively. Transverse reinforcement consisted of plain bars of 1/4-inch diameter set 25 cm on center in beams and 15 cm in columns; no transverse reinforcement was placed at the joints. Masonry infill, made of 15 cm-thick hollow concrete blocks, completely filled the transverse frames along lines 1, 3, 5, and 7. Short columns with 55 cm clear length were generated by the 1.70-m masonry infill that partially filled the longitudinal frame along line A. A stiff concrete bench located along line B also generated short columns (Figure 1b; IMME 1998).

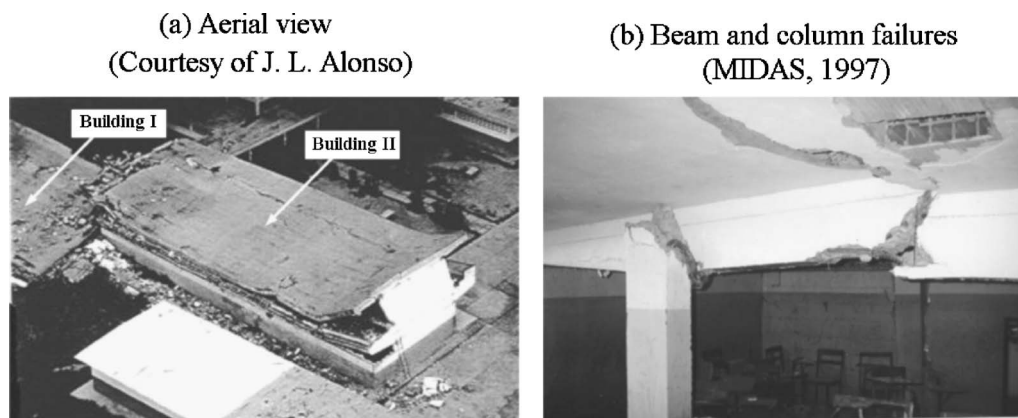
**Figure 2.** Structural failure of the VV school buildings during the 1997 Cariaco earthquake.

west) direction (Figure 2a), which is also the direction of the fault trace. Building I suffered a total collapse with the slabs resting on the ground, but Building II had a partial collapse with the slabs left resting on the masonry walls. Brittle shear failures in the short columns, ductile bending failures in the other columns, and combined beam-column failures were observed (Figure 2b).

The collapse of the VV school buildings was the result of a large seismic demand that could not be withstood because of: i) very low resistance and rigidity of the structure in the longitudinal direction, due to the small size of columns and the absence of beams; ii) the presence of short columns; and iii) the limited energy-dissipation capacity of the structural elements. The presence of the short columns precipitated a brittle shear failure in a structure that would have failed in any event, even developing all its low ductility. The failure was not the result of faulty construction; it was the result of well-known structural deficiencies in the seismic design of the buildings, certainly not foreseen in the standards in use 50 years ago.

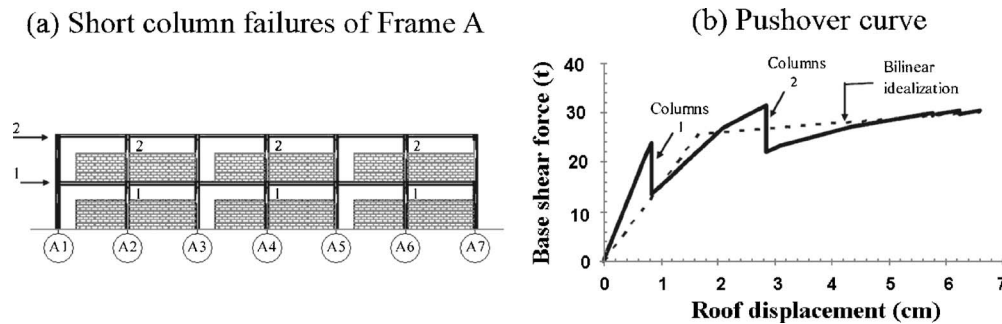
**Figure 3.** Pushover curve of VV School, Building I, showing the brittle shear failures in short columns of Frame A.

roof displacement imposed by the ground motion was estimated to be 17 cm (roof drift ratio of 2.8%), which is about 10 times the equivalent yield displacement and about 2.6 times the ultimate displacement (Figure 3b).

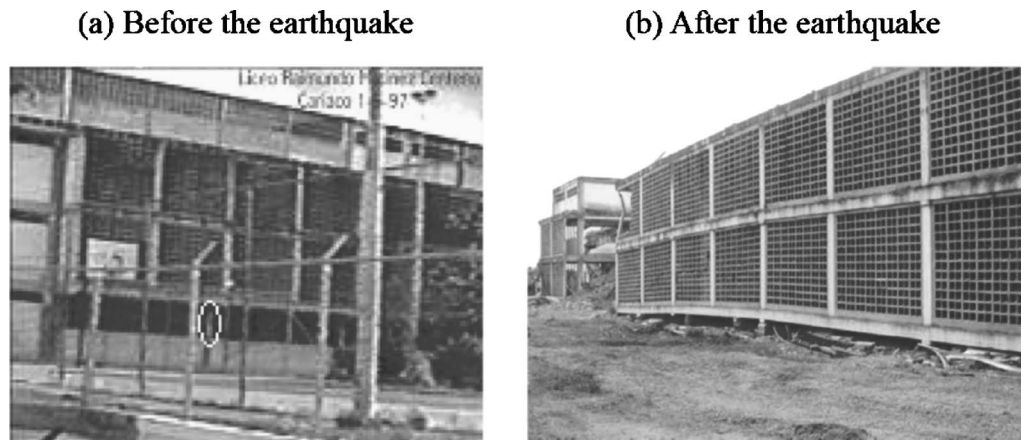
**Figure 4.** Building I of RMC School, before the earthquake (courtesy of E. Castilla) and after the earthquake, showing crushing of the first story (MIDAS 1997).

Both buildings exhibited similar behavior during the earthquake, consisting of failure of the columns at story one, leaving story two resting on the ground, with the larger

displacement along the east-west direction (Figure 4). Shear failures of short columns and compression failures and buckling of the longitudinal steel in other columns were observed on stories two and three (Figure 5).

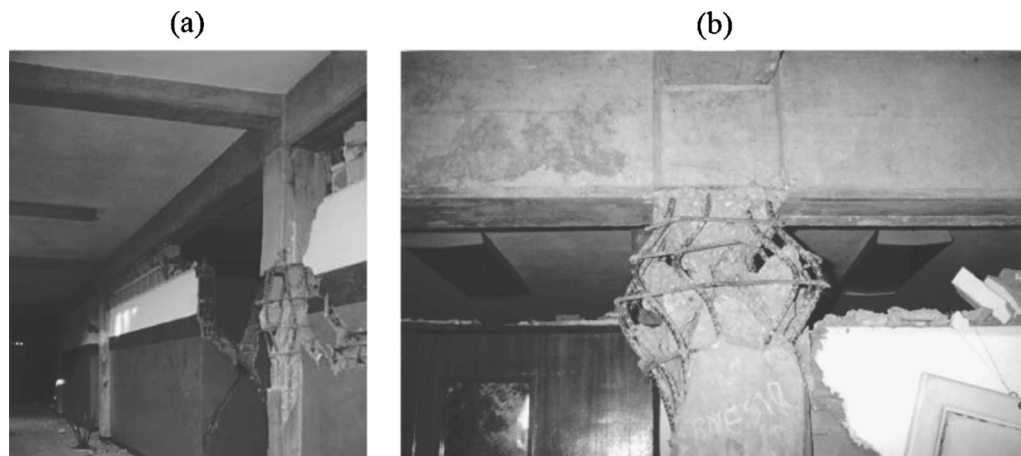
**Figure 5.** (a) Compression column failure and (b) shear column failure at the RMC School (MIDAS 1997).

The collapse of the two RMC school buildings was influenced by the combination of two factors: structural deficiencies typical of past design practices, and construction in a seismic zone with double the intensity stipulated in the design. The structural deficiencies were the presence of short columns that precipitated brittle failures, low strength, and the limited energy-dissipation capacity of the structure.

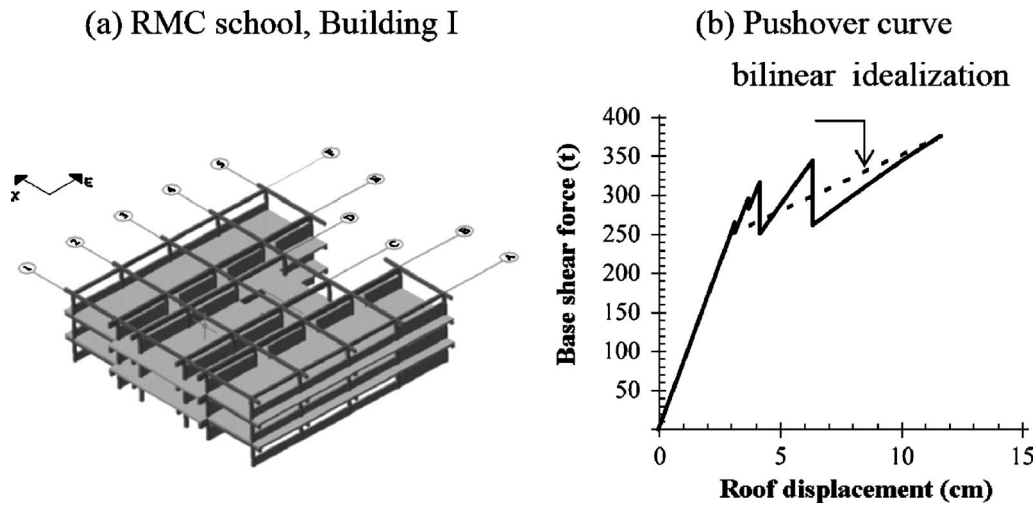
**Figure 6.** (a) Idealized model of the RMC school, Building I, showing masonry infill walls and short columns. The roof and masonry walls in the north-south direction are not shown. (b) Pushover curve in the east-west direction for Building I.

Mathematical modeling of Building I considers the contribution of the infill walls and effective moments of inertia for beams and columns (Figure 6a). The weight of the building is 1,900 tons and the initial elastic period is 0.69 s, corresponding to motion with a predominant component along the east-west direction. Modeling parameters for beams and columns are for non-conforming elements. The lateral load capacity (base shear force-roof displacement) of the building in the east-west (longitudinal) direction, the direction of the observed collapse, is shown in Figure 6b. The nonlinear response is initiated by the shear failure of nine short columns at the first story, followed by a similar failure at the short columns of the second and third stories (Puig 2006). The base shear force demand, obtained from an elastic dynamic analysis using the estimated fault-parallel pseudo-acceleration spectrum (Figure 1a), is about 1,500 tons, which exceeds 5.9 times the yield base shear force estimated from the bilinear idealized pushover curve (Figure 6b).

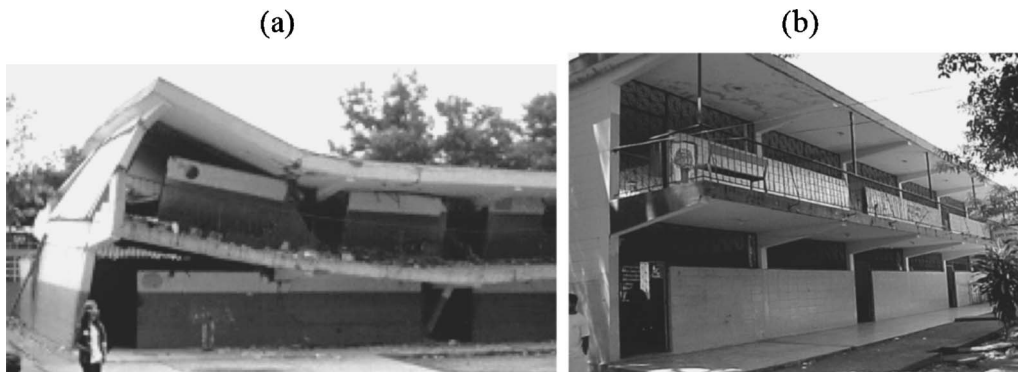
buildings is unknown, particularly in the case of the Old-type schools (Figure 9) that were built about 50 years ago. The Box-type schools are between 20 and 30 years old.

**Figure 9.** Old-type school buildings: (a) VV school that collapsed in Cariaco; (b) identical buildings can be found in several locations in the country.

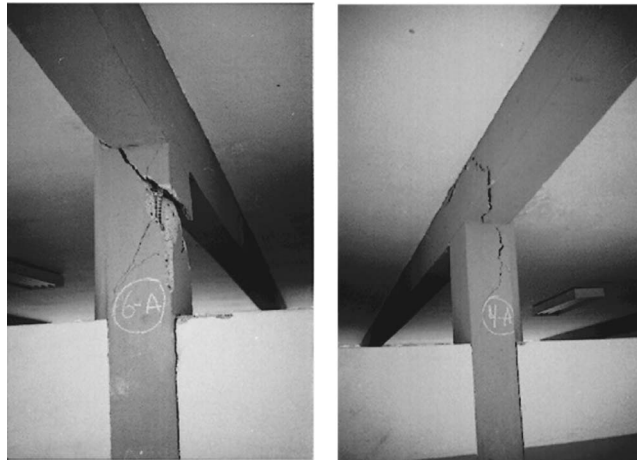
The ground acceleration from the 17 November 1991 moderate Curarigua earthquake ( $m_b=5.3$ , 16 km depth) was recorded at 47 km and 37 km from the epicenter, indicating horizontal peak accelerations of 0.037 g and 0.044 g, respectively (FUNVISIS 1991). That motion caused a brittle shear failure in three short columns of the first floor in an Old-type school (Figure 10) located at Arenales, 22 km from the epicenter, which was practically identical to the VV School that collapsed in Cariaco (Figure 9).

**Figure 10.** Shear failures in columns at an Old-type school building during a moderate seismic motion (courtesy of A. Morón).
