SEISMIC EVALUATION OF SCHOOL BUILDINGS IN VENEZUELA

A. Marinilli¹, N. Fernández¹, O. A. López¹, and G. Coronel¹

ABSTRACT

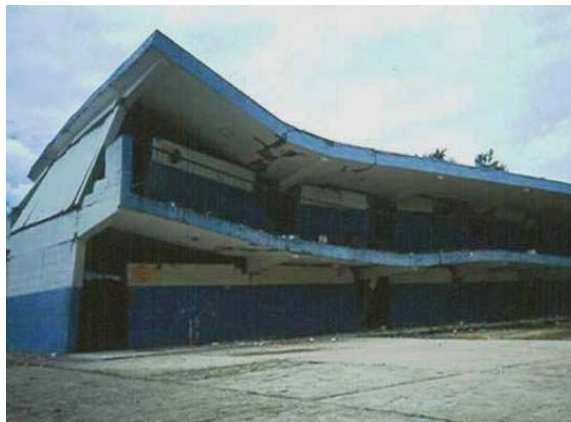
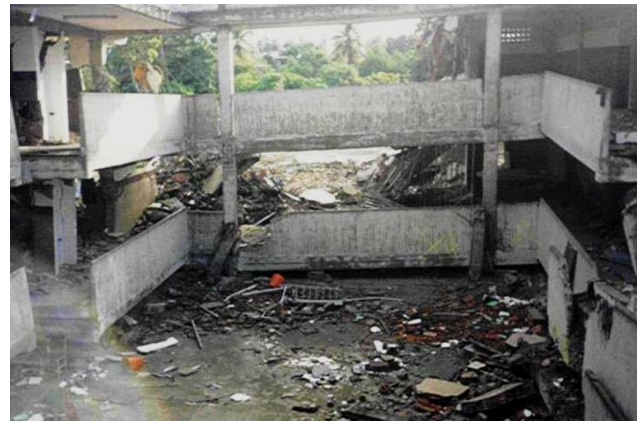
Figure 2. School buildings collapsed during 07/09/1997 Cariaco Earthquake (Mw=6.9): (a) Valentin Valiente School and (b) Raimundo Martinez Centeno High School.

The school buildings that collapsed during the 1997 Cariaco Earthquake were used to calibrate the proposed indexes. The school buildings were located in the town of Cariaco (Sucre State in the northeast region of Venezuela), which is located in the Seismic Zone 7 (PGA=0.4g for T=475 years). Valentin Valiente School was constructed in mid-1950 decade and was composed by two “Old-Type I” buildings separated by a structural joint (see for instance Figure 2a). It was distinguished by the lack of earthquake resistant lines in its longitudinal direction and the presence of a large amount of short columns in both of its stories. Raimundo Martinez Centeno High School was constructed in mid-1980 decade and was a “Box-Type” building composed by two c-shaped buildings separated by a structural joint (see Figure 2b). It possessed earthquake resistant lines in two orthogonal directions and was distinguished by a large amount of short columns in all of its stories. Table 2 shows the index values obtained for Valentin Valiente School and Raimundo Martinez Centeno High School.

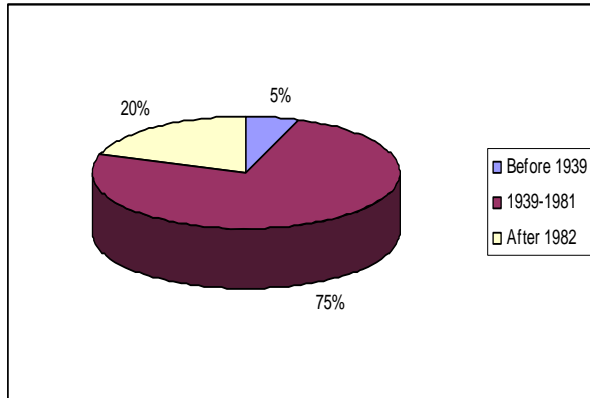
Figure 4 shows the distribution of year of design and/or construction for all the inspected school buildings. A total of 80% of the inspected buildings are dated before benchmark year 1982 and 5% before benchmark year 1939. Figure 5 shows the distribution of building type for all the inspected buildings. It can be seen that 36% of the inspected buildings are similar to those collapsed during 1997 Cariaco Earthquake (Box-Type and Old-Type I).

Figure 4. Year of design and/or construction for the inspected school buildings.

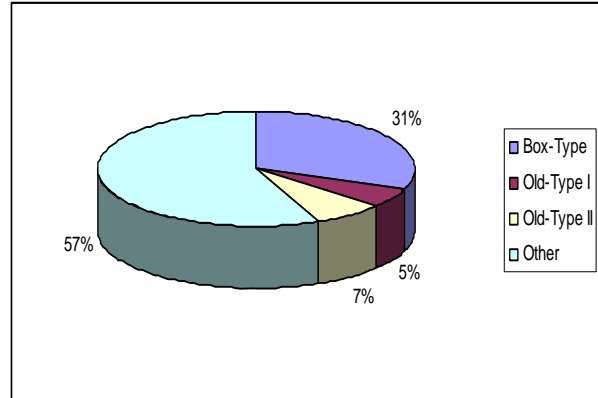
Figure 5. Building type for the inspected school buildings.

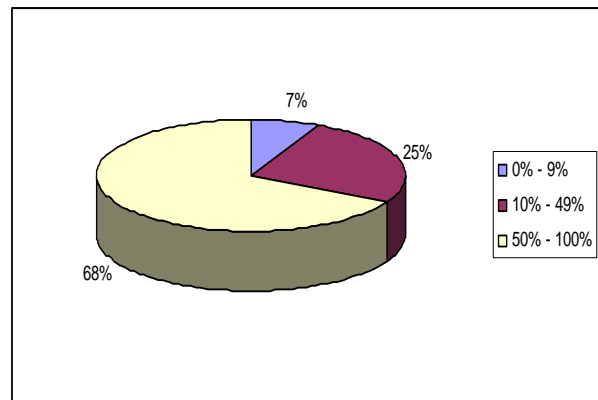
Figure 7. Amount of short columns for the inspected buildings.

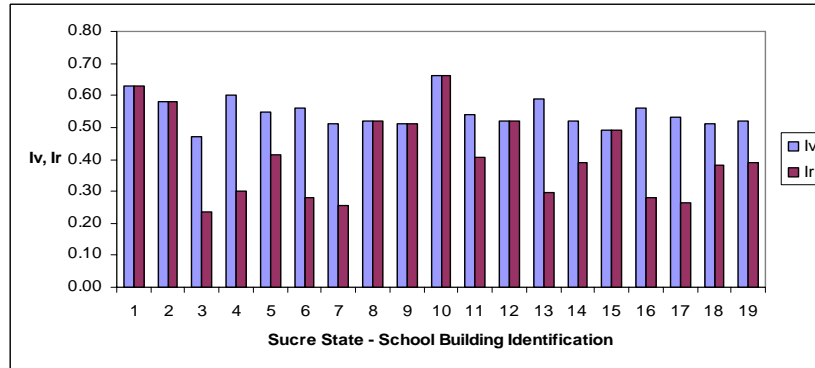
Figure 8. Vulnerability Index (I_v) and Risk Index (I_r) obtained for school buildings inspected in Sucre State.

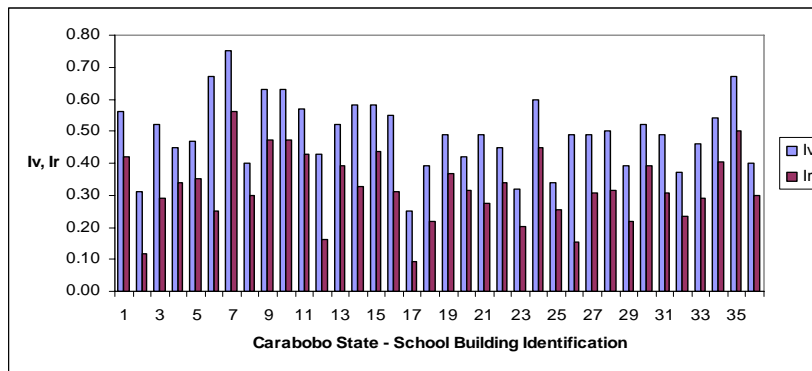
Figure 9. Vulnerability Index (I_v) and Risk Index (I_r) obtained for school buildings inspected in Carabobo State.

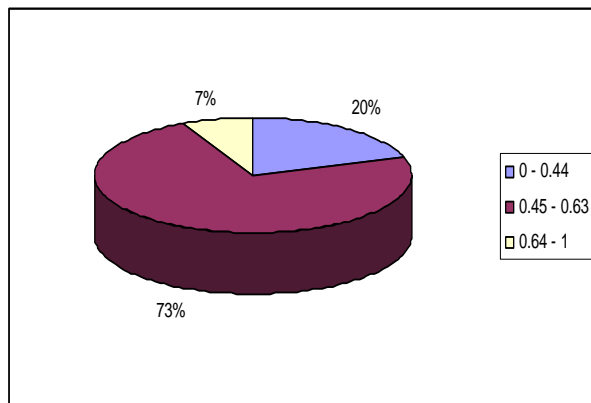
Figure 8 and Figure 9 show the vulnerability index and risk index values obtained at each school building in Sucre State and Carabobo State, respectively. Figure 10 shows that 80% of the sample showed vulnerability index values equal or greater than the value obtained for Raimundo

Martinez Centeno High School ($I_v = 0.45$), regardless of the seismic zone where they are located. Otherwise, Figure 11 shows that 55% of all of the inspected school buildings showed risk index values equal or greater than the value obtained for Valentin Valiente School ($I_r = 0.32$).

Figure 10. Vulnerability Index (I_v) obtained for the inspected buildings.

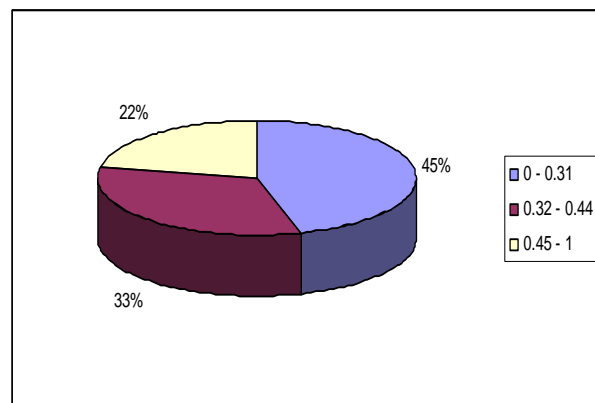
Figure 11. Risk Index (I_r) obtained for the inspected buildings.
