Inspection of School Buildings in Seismic Prone Areas in Venezuela

A. Marinilli, N. Fernández, O. A. López & G. Coronel
Instituto de Materiales y Modelos Estructurales IMME.
Facultad de Ingeniería. Universidad Central de Venezuela

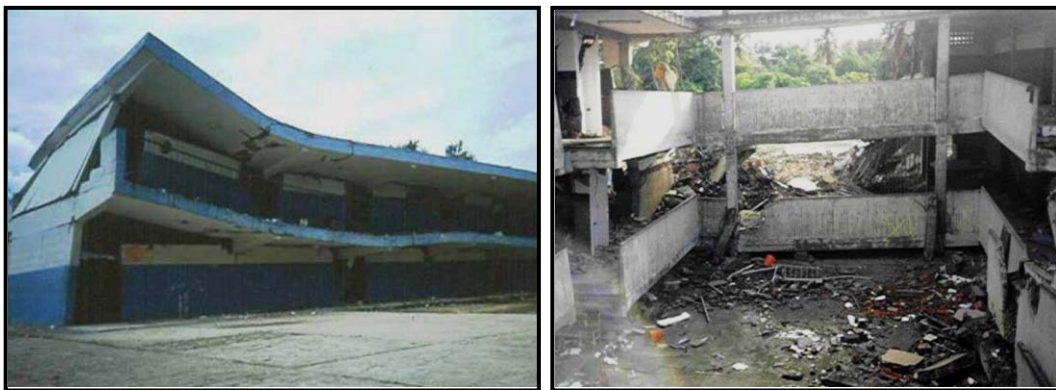
Figure 2. School buildings that collapsed during 07/09/1997 Cariaco Earthquake ($M_w=6.9$): Valentin Valiente School (left) and Raimundo Martinez High School (right)

The school buildings that collapsed during the 1997 Cariaco Earthquake were used to calibrate the proposed indexes. The school buildings were located in the town of Cariaco (Sucre State in the northeast region of Venezuela), which is located in the Seismic Zone 7. Valentin Valiente School was constructed in mid-1950 decade and was composed by two “Old-Type I” buildings separated by a structural joint (see for instance Figure 2). It was distinguished by the lack of earthquake resistant lines in its longitudinal direction and the presence of a large amount of short columns in both of its stories. Raimundo Martinez High School was constructed in mid-1980 decade and was a “Box-Type” building composed by two c-shaped buildings separated by a structural joint (see Figure 2). It possessed earthquake resistant lines in two orthogonal directions and was distinguished by a large amount of short columns in all of its stories. Table 1 shows the index values obtained for Valentin Valiente School and Raimundo Martinez High School.

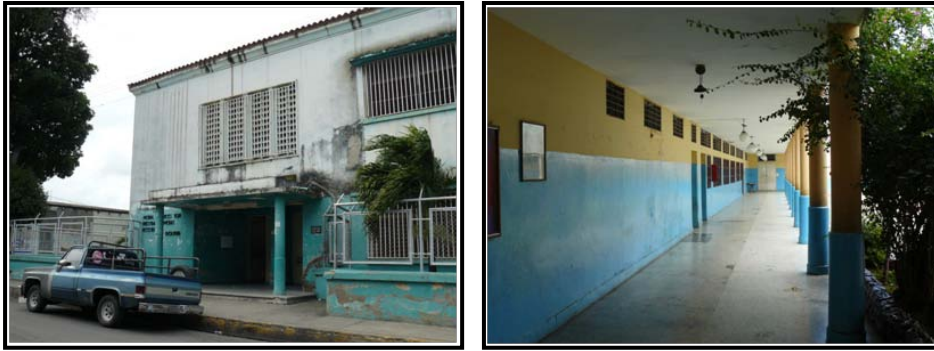
Figures 6 to 9 show some examples of school buildings inspected in Sucre State (Seismic Zones 6 and 7 in northeast region of Venezuela). Figure 6 shows an old school building where it was observed the lack of clearly defined lines of seismic resistance in two orthogonal directions. Figure 7 shows two Old-Type I school buildings. It was observed only one clearly defined line of seismic resistance and several short columns in both buildings. Figure 8 shows a Box-Type school building where only one line of seismic resistance could be clearly identified during the inspection; however it is known that there are squat beams in the orthogonal direction. Figure 9 shows a modern school building where two orthogonal seismic resistance lines were clearly identified, but several short columns were identified as well.

Figure 6. Old school building inspected in Sucre State

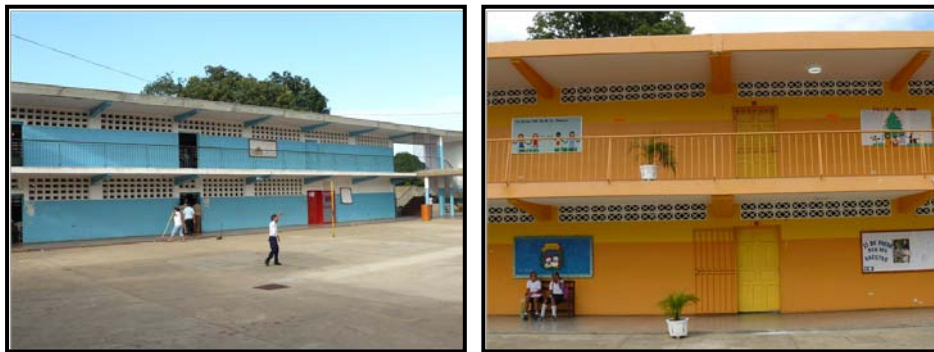
Figure 7. Old-Type I school buildings inspected in Sucre State

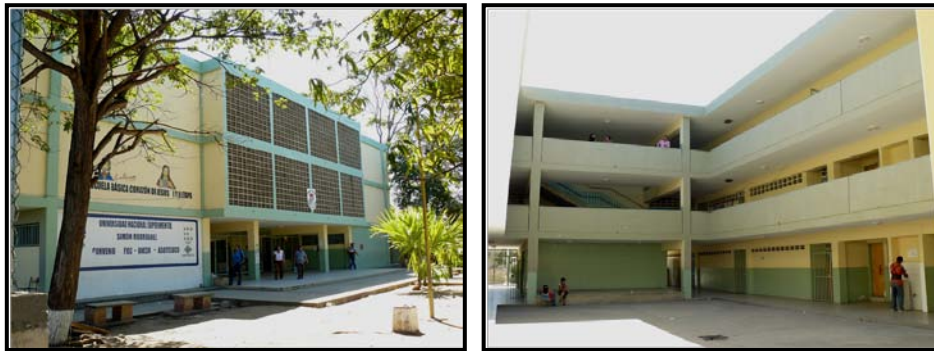
Figure 8. Box-Type school building inspected in Sucre State

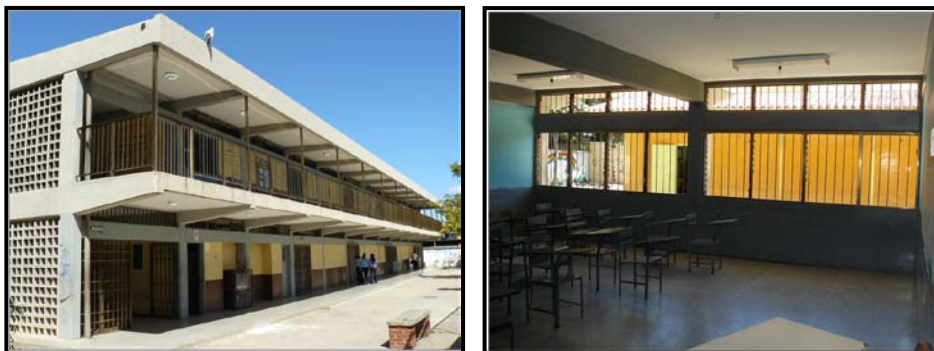
Figure 9. Modern school building inspected in Sucre State
