SEISMIC RISK REDUCTION IN VENEZUELAN SCHOOLS

ABSTRACT

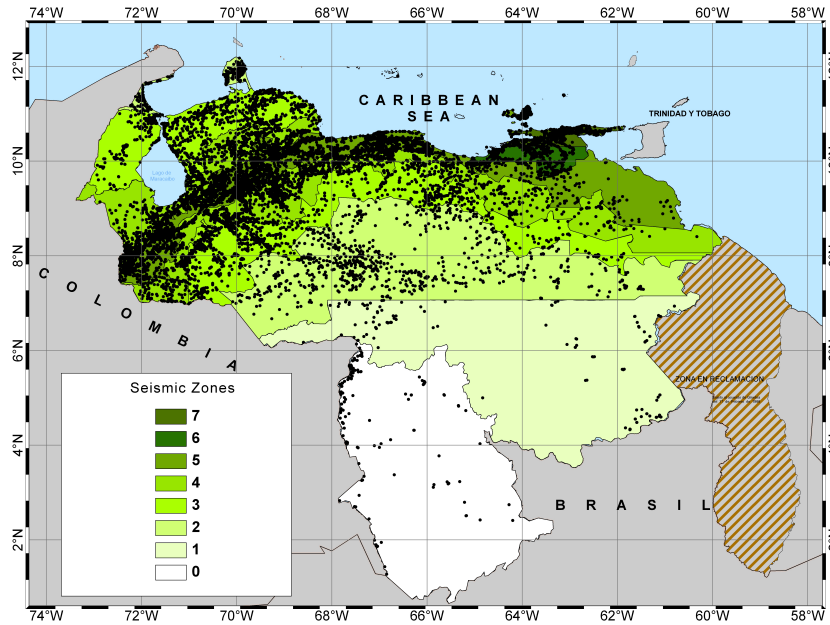
Figure 1. Seismic zone map and location of school buildings in Venezuela.

The 28,878 schools in Venezuela are distributed at each zone as shown in Table 1 and Figure 1. The PGA values vary at each zone to a maximum of 0.4g in Zone 7, for return periods $T=475$ years (COVENIN 2001). About 70 % of the schools are in zones of high hazard ($0.25g \leq PGA \leq 0.40g$). The dots plotted in Figure 1 show the location of 18,685 school buildings that have been incorporated in a geographical information system (GIS) aiming to generate an integrated instrument to simulate earthquake occurrence and expected damage and losses.

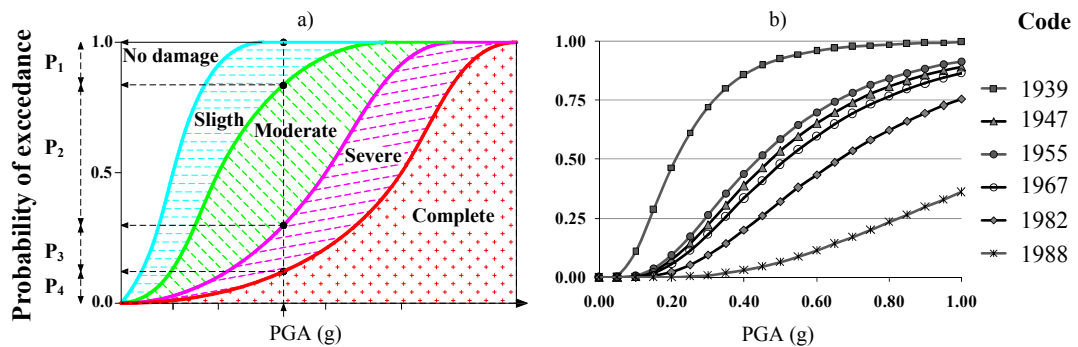
Figure 2: a) Example of the fragility curves for each damage state; b) Fragility curves for the complete damage state for 2-story buildings designed with different codes.

The vulnerability of a school building is characterized by approximate fragility curves that are expressed as a function of the PGA. The goal is to facilitate decision making to develop plans for prevention and risk reduction. The buildings are supposed to satisfy the design code in force at the year of construction. A bilinear capacity curve is developed: i) The yield base shear is estimated from the design shear specified in the code, incorporating an overstrength; ii) The yield displacement is calculated assuming the fundamental period and that the dynamic response is contained in the fundamental mode; iii) The ultimate displacement is estimated assuming a ductility capacity associated with each code (Coronel and López 2009). Four damage states are defined: (1) Slight, (2) Moderate, (3) Severe, and (4) Complete (Figure 2a). Each damage state is represented in the capacity curve selecting the yield and ultimate displacements. The fragility curves are defined using a lognormal distribution, adopting standard deviations recommended in (FEMA-NIBS 2009; Bonett 2003). Figure 2b shows the fragility curves for the complete damage state for 2-story schools in seismic zone 7, for the six codes.

The probability of occurrence (P_i) of each damage state (i) is obtained from the fragility curves for a given PGA value (Figure 2a). The Damage ratio (D_i) is defined for each damage state as a percentage of building replacement cost, as shown in Table 3 (Blondet et al. 2005). The risk index (R_i) is obtained by weighting the probability of occurrence with the damage

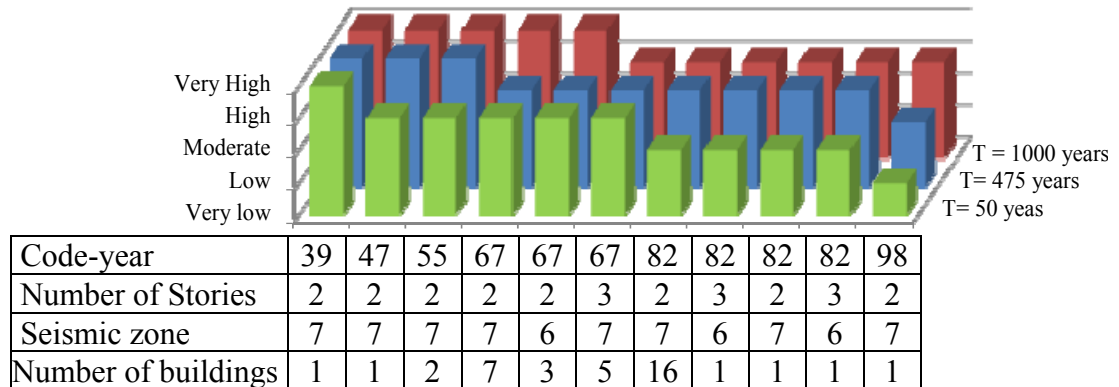
Figure 3. Risk level for 42 buildings in the Sucre State for different return periods.

ratio: $R_i = \sum P_i D_i$. A Risk level is defined associated with ranges of R_i , as shown in Table 3. Four Risk levels are defined: Very low, Low, Moderate, High and Very High. Figure 3 shows the estimated risk levels for a group of 42 school buildings located in the Sucre State of Venezuela, in the seismic zones 6 and 7; the number of stories and the year of the corresponding design code are also indicated. Results are presented for $T= 50, 475$ and 1000 years, associated with PGA values of $0.20g, 0.40g$ and $0.50g$ in Zone 7 and $0.18g, 0.35g$ and $0.44g$ in Zone 6, respectively. Figure 4 shows risk levels calculated for 547 school buildings in the Sucre State for $T= 475$ years. Since 56 % of those buildings were built before 1982, 53 % of them have a risk that is characterized as Very High.

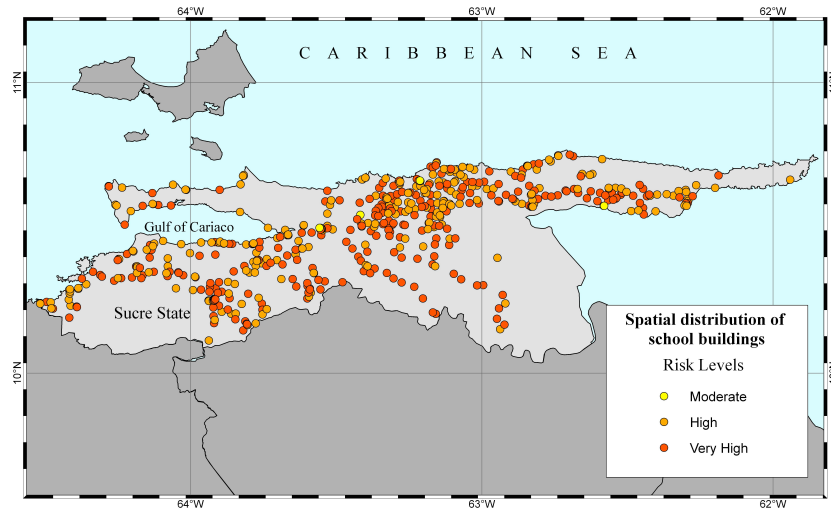
Figure 4. Risk level for 547 schools buildings in Sucre State for $T=475$ years.

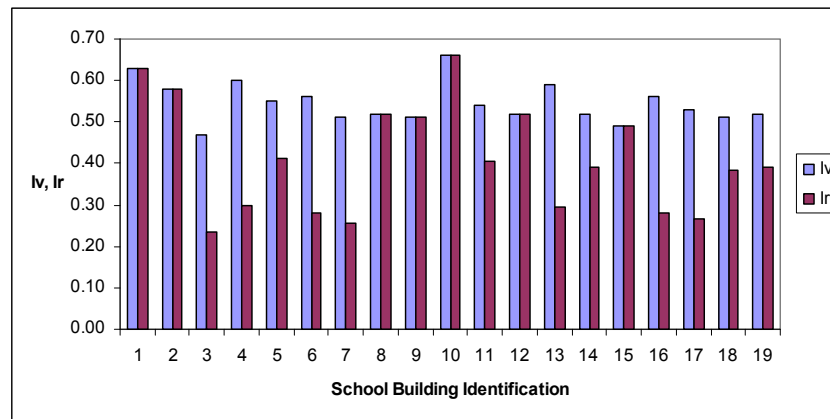
Figure 5. Vulnerability Index (Iv) and Risk Index (Ir) for schools in Sucre State.

of the country. As an example of the results obtained during the inspections, Figure 5 shows the vulnerability index and risk index values obtained for 19 school buildings inspected in Sucre State. All buildings show risk index values greater than the value obtained for MC High School (0.45), and more than 60% of the buildings show risk index values greater than the value obtained for VV School (0.32). Additional information is given in the companion paper (Marinilli et al. 2010). This information will be used to establish priorities to perform detailed studies and rehabilitation of school buildings. Additionally, 10 buildings were selected in a first stage as pilot projects for retrofitting and preparedness plans carried out into the “Seismic-Classroom” Project (FUNVISIS 2010).

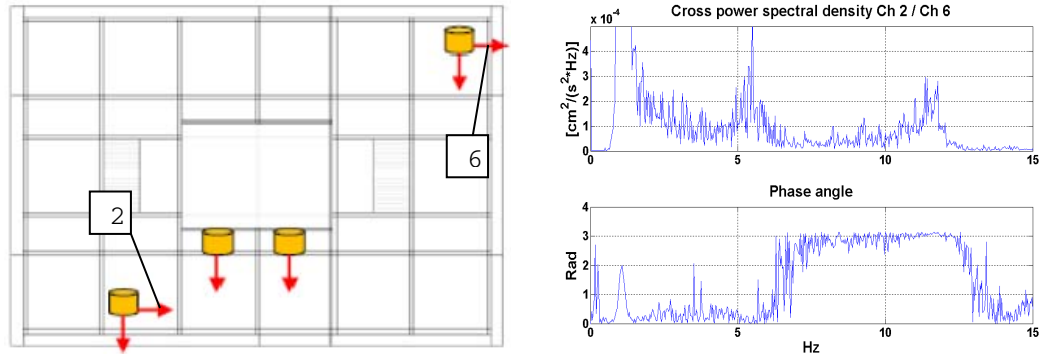
Figure 6. Layout of accelerometers, sample of cross spectral density and phase angle.

From ambient vibration tests the natural periods, mode shapes and damping ratios of the first vibration modes were determined for the school buildings selected as pilot projects, in order to evaluate those properties in current building conditions before structural retrofitting is performed. Each building was instrumented with six 1 Hz seismometers placed at the highest floor, as shown for the *Corazón de Jesús* Box-Type school in Figure 6. Non-parametric methods of signal processing were used for the determination of the dynamic properties. The data for each sensor goes to an A/D converter with a sampling rate set to 200 Hz; frequencies of interest rarely overpass 100 Hz. For each record, the power spectra were calculated with 60% overlap and 214 data points. A Hanning window was used to calculate the mean square Fourier spectrum. The vibration modes were calculated from the cross correlation analysis of two simultaneous records, as illustrated in Figure 6. The vibration modes were determined for phase angles of 0° or 180° for the common frequencies in the different records. With the vibration amplitude for each frequency at each point, it was possible to draw an approximate vibration mode for the building. The modal damping was calculated from the power spectra by the half power method, assuming that the damping is small. Table 4 presents results for five selected schools; high frequency values are observed due to the small vibration amplitudes with a strong influence of the non structural components, particularly the masonry infill walls. Damping ratios vary from 2 to 10 %. Dynamic properties will be measured again after structural retrofitting is completed.

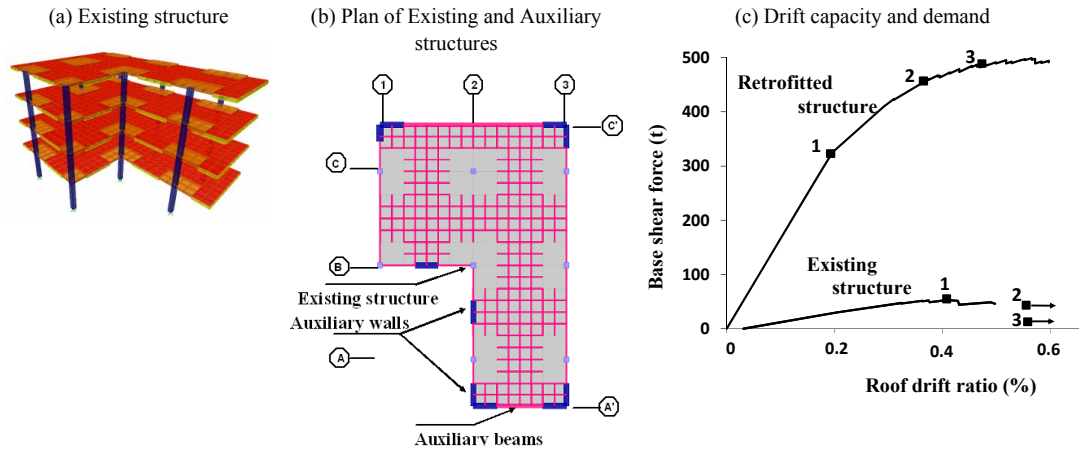
Figure 7. Retrofitting of a Flat-Slab school building

The L shaped plan building (Figure 7) built in 1986 is located in Caracas (Zone 5). The 4-story reinforced concrete structure has a 30 cm deep joist floor slab with ribs along two directions, supported by 8 columns with a cross-section of 40 cm x 40 cm. All bay lengths are 6.9 m; cantilever lengths are 3.4 m. Total height is 12.8 m and weight is 963 t. Foundations consist of reinforced concrete deep piles. Infill walls of 15 cm-hollow clay blocks are present in most of the upper story bays. Concrete strength was 250 k/cm^2 ; steel yield stress was 4200 k/cm^2 . Columns hoops of 3/8-inch diameter were installed 12.5 cm on center near the joints and 25 cm further away from the joints, with 90-degree hooks and no transverse reinforcement at the joints. The period considering effective stiffness values is 1.31 s without infill walls and 0.66 s with them. The roof drift demand was determined by means of the coefficient method (FEMA 2005); ground motions 1, 2 and 3 were defined by PGA values of 0.14, 0.30 and 0.39g, for return periods of 50, 475 and 1000 years, respectively. The roof drift demand neglecting the infill walls are plotted on the pushover curve (Figure 7); seismic motions 2 and 3 exceed the capacity of the existing structure. The retrofitting adds an auxiliary structure consisting of 6 reinforced concrete structural walls and 2 connecting beam at each floor (Figure 7). The auxiliary structure is connected to the building by the floor slabs acting as diaphragms, which are strengthened at the wall-slab joints. Structural walls are supported by reinforced concrete micro-piles. The period of the retrofitted building is 0.38 s without masonry walls and 0.29 s with them. The increase of stiffness and strength of the retrofitted structure is shown in Figure 7; the drift demand is kept below 0.5% in order to protect the existing non-ductile structure that supports the gravity loads. The cost of the structural retrofitting is estimated to be 22 % of the replacement cost.

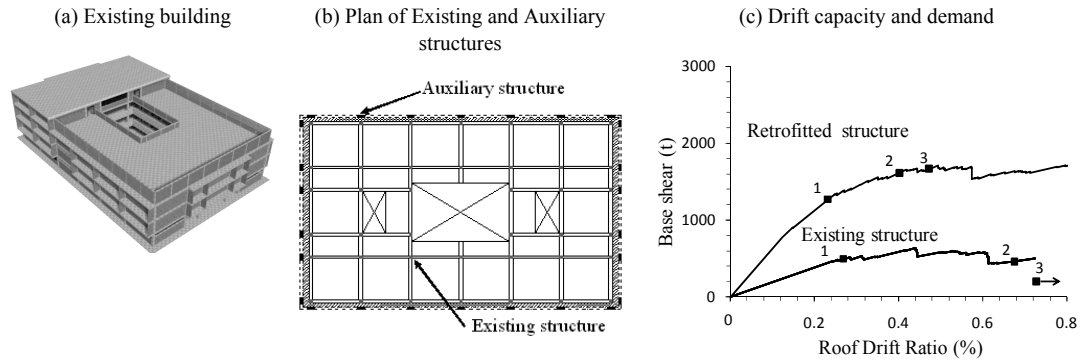
Figure 8. Retrofitting of a Box-Type school building.

This section summarizes the retrofitting project of a Box-Type building located in Caracas (Zone 5) and built in 1970. It has a rectangular plan with an opening at the middle (Figure 8). The 4-story building has a reinforced concrete space frame; cross-sections are 40 cm x 40 cm for columns and 40 cm x 60 cm for beams in the longitudinal direction. The transverse beams are shallow beams having 40 cm x 30 cm dimensions. The concrete joist floor system is 30 cm deep with ribs along the transversal direction. There are 7 transverse frames spaced at 7.2 m and 6 longitudinal frames spaced a 7.20 and 3.60 m. The total height is 12.30 m. Infill walls of 12 cm-thick hollow clay blocks are located in most bays. From the 42 columns of the building, 10 are short columns of 0.35 m in length and 14 of 1.37 m, created by the infill in the longitudinal direction, at each story. Total weight is 3800 t. Columns hoops of $\phi 3/8$ -inch were installed 12 cm on center near the joints and 20 cm further away from the joints, with 90-degree hooks and no transverse reinforcement at joints. The periods are 1.05 s and 0.90 s, for motion along the longitudinal and the transversal directions, respectively, considering the infill walls and effective stiffness values. The roof drift demand was calculated for ground motions 1, 2 and 3 and plotted in Figure 8 for the longitudinal direction. The roof drift demand exceeds the drift capacity for ground motions 2 ($T=475$ years) and 3 ($T=1000$ years). The retrofitting scheme adds an auxiliary reinforced concrete structure along the perimeter of the building, supported on micro-pile foundations. Figure 8 shows the pushover curve for the retrofitted structure; roof drift demands are kept below the values that could threaten the capacity of the existing structure to support the gravity loads. The cost of the structural retrofitting is about 15 % of the replacement cost.

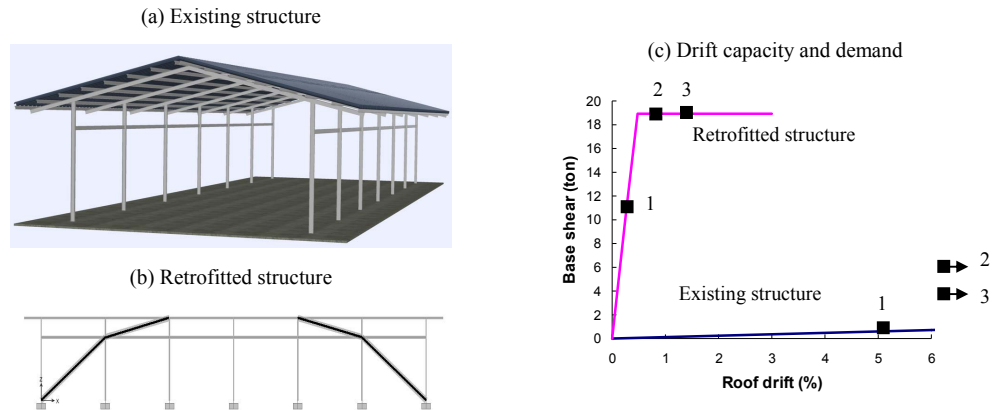
Figure 9. Retrofitting of a Rural School building

The Rural school shown in Figure 9a is a flexible structure with a lightweight roof supported on steel beams and columns. It weighs approximately 5.60 t and has periods of 2.38 s and 0.34 s in the longitudinal and transversal direction, when the masonry infill walls are not considered. Some infill walls overturned during the 1997 Cariaco earthquake. For Seismic Zone 5, roof drift demand in the longitudinal direction for ground motions 2 and 3 exceeds the

limit of 3% assigned for this structure (Figure 9c). A retrofitting solution adds diagonal braces in the longitudinal direction and haunched beams in the transversal direction (Figure 9b). The lightweight roof is also replaced by a heavier roof increasing the weight to 31.6 t. The periods are reduced to 0.30 s and 0.32 s in the longitudinal and the transverse directions. Roof drift demand for the retrofitted structure shown in Figure 9c are kept below 1.5%.
