# Reducing Seismic Risk of School Buildings in Venezuela

Oscar A. López,<sup>a)</sup> M.EERI, Julio J. Hernández,<sup>a),b)</sup> M.EERI, Gianina Del Re,<sup>a)</sup> José Puig,<sup>a)</sup> and Luis Espinosa<sup>a)</sup>

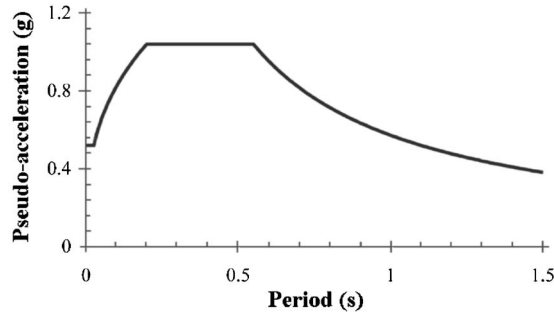
(a) Pseudo-acceleration spectrum

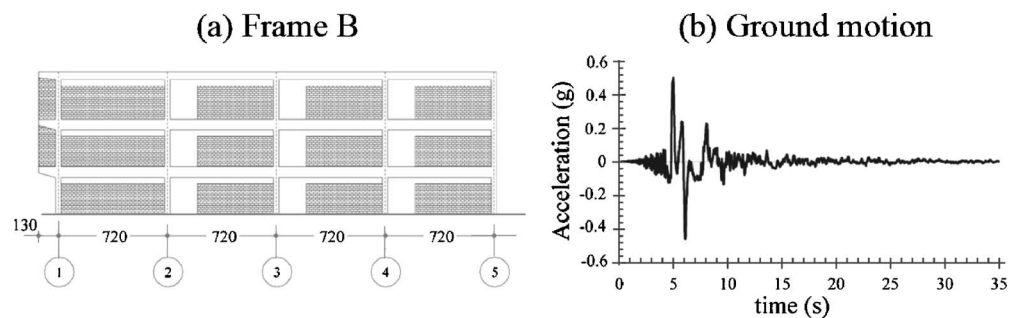
The nonlinear response history of frame B (or identical frame E) was investigated; these frames are the critical frames of the building due to the large number of short columns (70 cm long; Figure 7a). The analysis was performed for several ground acceleration records: the motions recorded at Stations 5028 (Array 7) and 942 (Array 6) during the Imperial Valley earthquake (10/15/1979), which were selected given the similarities

**Figure 7.** (a) Frame B of RMC School, Building I; (b) scaled Imperial Valley accelerogram (15 October 1979), Station 5028 (Array 7), longitudinal component.

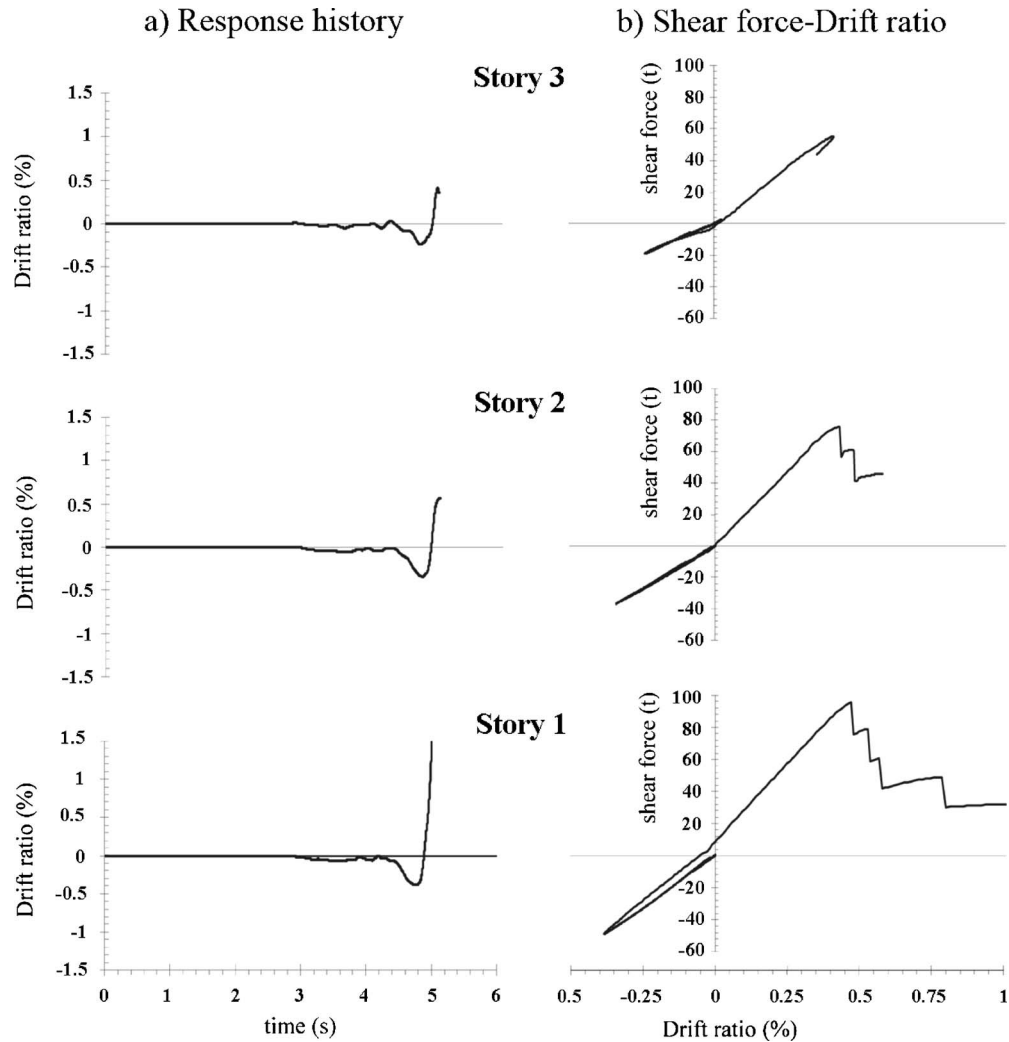
in magnitude, distance to rupture, and soil condition; and the accelerogram recorded at 20 km from the rupture surface during the Cariaco earthquake. All the accelerograms were scaled to 0.52 g peak acceleration. Selected results are presented in Figure 8 for the longitudinal component at Array 7 (Figure 7b). Figure 8a shows the drift ratio response history at each story. The shear-drift response at each story is presented in Figure 8b. The collapse of the structure is reached toward the west at a drift ratio of 1.2% in story one at about 5.1 seconds, due to the brittle shear failure of the four short columns at story one and the flexural failure of the last column at the same story. At this moment the response of story three is essentially elastic (drift ratio less than 0.4%), and story two shows the brittle shear failure of two short columns. The failure mode that emerges from these analytical results is similar to the observed behavior, consisting of a large displacement toward the west that led to the collapse and crushing of the first story (Figure 4b) and the shear failure of some columns at the second story (Figure 5b). Response histories to the other acceleration records show similar patterns (López and Espinosa 2007).

**Figure 8.** Response at each story of frame B to the scaled Imperial Valley accelerogram. (a) Drift ratio response history; (b) shear force-drift ratio response.

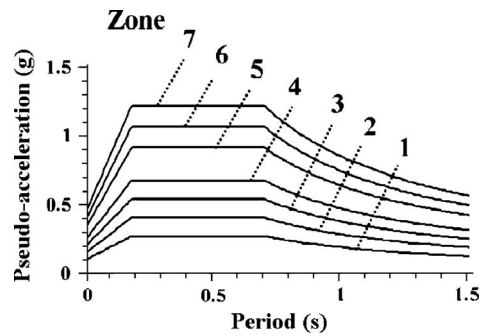
Figure 11. Pseudo-acceleration spectra for each seismic zone, for stiff soil.

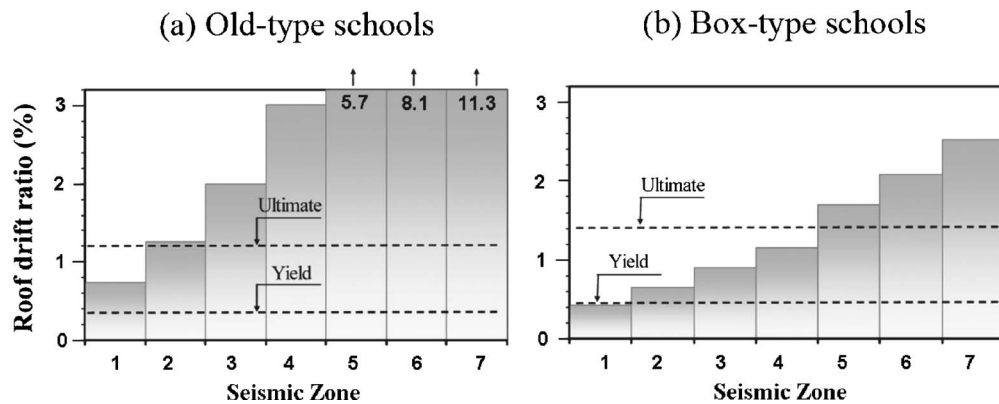
The Old-type and Box-type schools were selected for evaluation because they are identical to the collapsed schools in Cariaco and are found all over the country. Roof drift demands were estimated at each seismic zone using the nonlinear static procedure (FEMA 2000) for the ground motions specified in the national code (Table 1). Figure 11 shows the pseudo-acceleration spectrum for each zone; stiff soil condition is assumed to be representative for most cases and is adopted for estimation purposes. The yield strength and the ultimate drift values are taken from the results of the pushover analysis (Figures 3 and 6), assuming that those values represent the behavior of the standard schools in each seismic zone. An improved estimation will require on-site investigations at each specific building, which is part of the national program described below. Results of this approximate assessment for the Old-type schools presented in Figure 12a indicate that the ultimate roof drift ratio is exceeded in most of the seismic zones and points out the need for retrofitting even in the moderate-hazard zones. Results for the Box-type school (Figure 12b) show that the ultimate drift ratio is exceeded only in the high and very high hazard zones (zones 5 to 7, Table 1).

Figure 12. Roofs drift ratio demand, yield, and ultimate drift at each seismic zone for Old-type and Box-type schools.
