Inspection of School Buildings in Seismic Prone Areas in Venezuela

A. Marinilli, N. Fernández, O. A. López & G. Coronel
Instituto de Materiales y Modelos Estructurales IMME.
Facultad de Ingeniería. Universidad Central de Venezuela

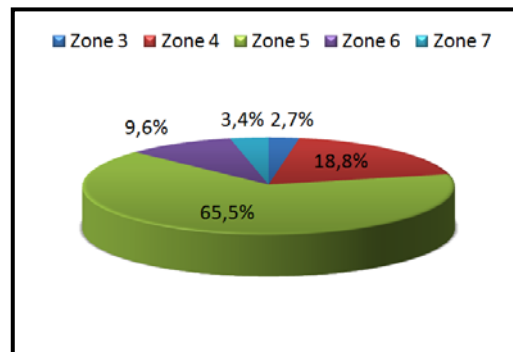
between 0.30g and 0.40g for return period of $T=475$ years) and 21.5% of the inspected buildings were located in intermediate hazard seismic zones (PGA values between 0.20g and 0.25g for $T=475$ years).

Figure 3. Distribution of inspected schools according to Seismic Zones in Venezuela

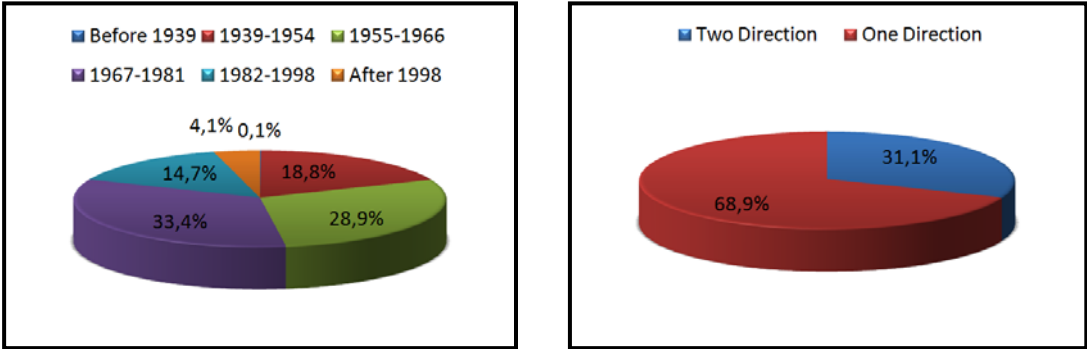
Figure 5 (left) shows the distribution of inspected schools according to year of design and/or construction. A total of 47.8% of the inspected buildings are dated before 1967, 33.4% between 1967 and 1982, and 18.8% after 1982. Figure 5 (right) shows the distribution of inspected school buildings according to the number of seismic resistance lines. Only in 31.1% of the inspected buildings two orthogonal lines of seismic resistance could be clearly identified.

Figure 5. Distribution of inspected schools according to year of design and/or construction (left) and number of lines of seismic resistance (right)

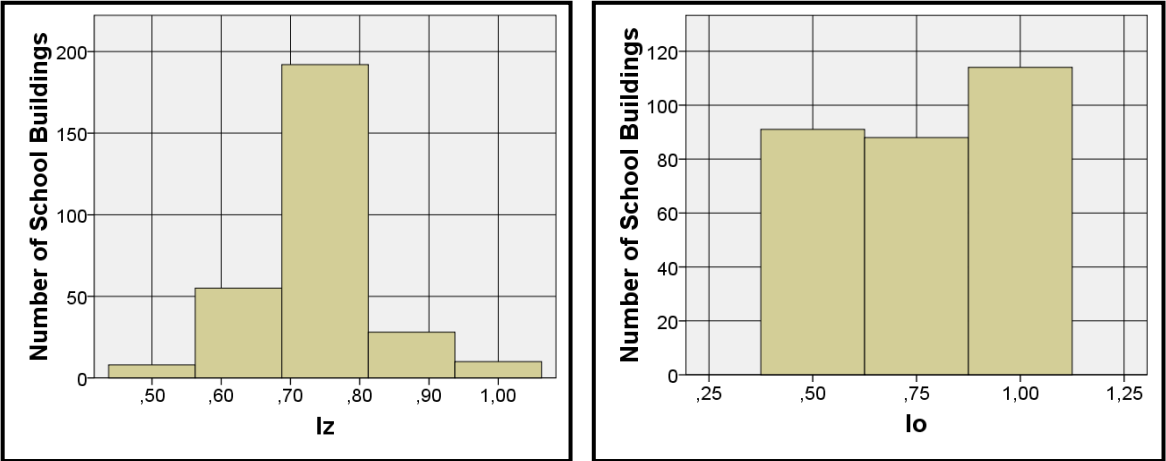
Figure 10 (left) shows the seismic hazard index distribution for inspected schools. About 78.5% of the inspected buildings showed $I_z \geq 0.75$ because, as it was previously discussed, they are located in high hazard seismic zones. Figure 10 (right) shows the occupation index distribution. About 68.9% of the inspected school buildings showed $I_o \geq 0.75$, corresponding to school capacities greater than 500 students.

Figure 10. Distributions of seismic hazard index (left) and occupation index (right) for inspected schools

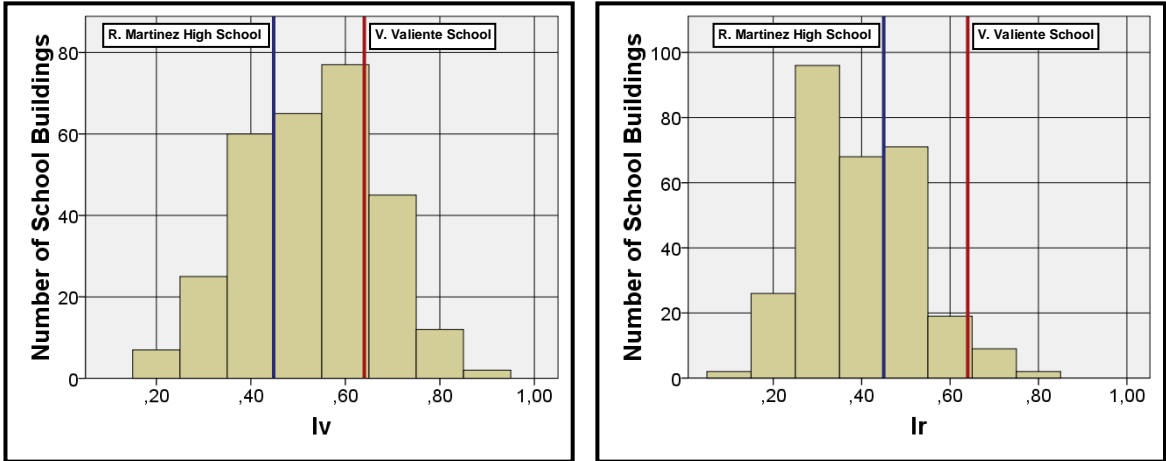
Figure 11 (left) shows the vulnerability index distribution for the inspected school buildings. Comparing the results with those obtained for school buildings that collapsed during 1997 Cariaco Earthquake, it was observed that about 68.6% of the inspected buildings showed $I_v \geq 0.45$ and about 20.1% showed $I_v \geq 0.64$. Figure 11 (right) shows the risk index distribution for the inspected school buildings. Similarly, it was observed that about 31.4% of the inspected buildings showed $I_r \geq 0.45$ and about 4.4% showed $I_r \geq 0.64$.

Figure 11. Distributions of vulnerability index (left) and risk index (right) for inspected schools

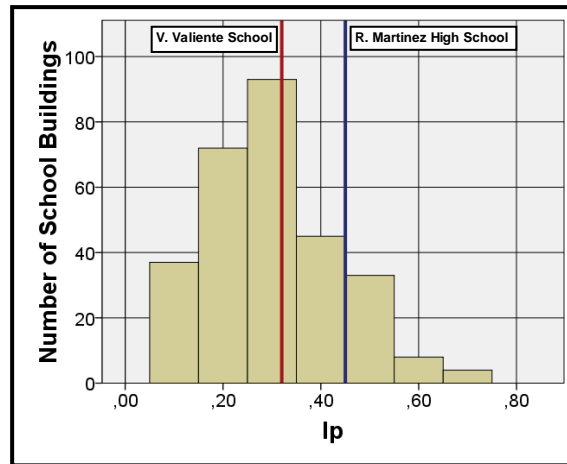
Figure 12 shows the prioritization index distribution for the inspected school buildings. It was observed that about 41.4% of the inspected buildings showed $I_p \geq 0.32$ and about 14.7% showed $I_p \geq 0.45$.

Figure 12. Distributions of prioritization index for inspected schools
